# MNDOT I-494 CORRIDOR

EROSION CONTROL

## STABILIZING SLOPES ALONG A LIVE FREEWAY

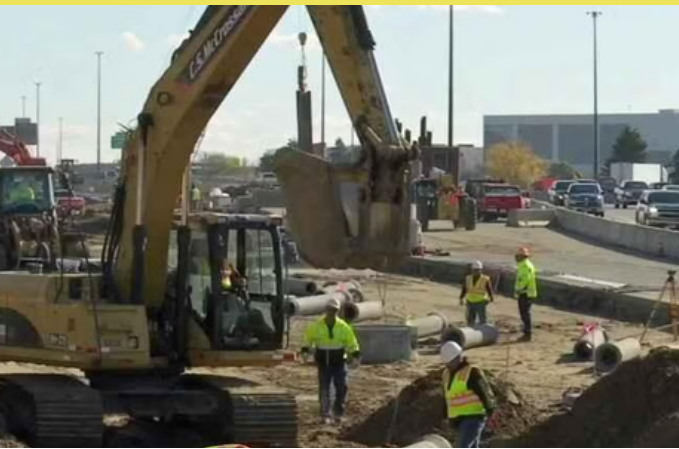
## HIGH-STRENGTH BLANKET DELIVERS STABILITY

To address these conditions, the project team selected the Ero-Guard EG-2X-NN erosion control blanket for slope stabilization and turf establishment. The blanket's curled excelsior fibers and double jute netting formed a dense, interlocked matrix designed to resist runoff, wind, and traffic-induced forces. Its MnDOT Category 25 designation confirmed suitability for high-stress turf establishment, while the biodegradable design provided long-term performance without environmental impact.

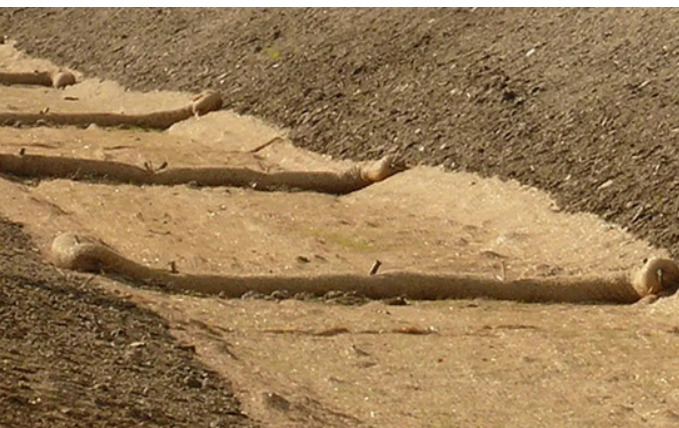
Crews installed the blanket under active freeway conditions, fine-grading slopes, applying seed, and unrolling the material downslope with a six-inch anchor trench at the crest. Overlaps ensured continuous coverage, and dense staple patterns secured the blanket near pavement edges, culverts, and high-exposure zones. Temporary wind barriers and daily inspections helped crews maintain stability throughout installation and early growth stages.

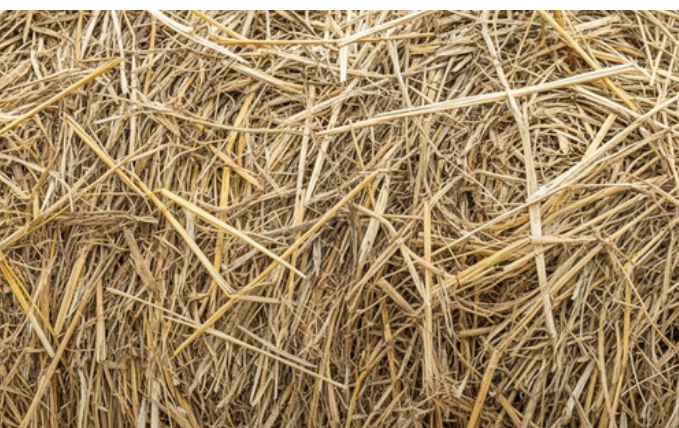
Despite heavy summer storms and constant traffic exposure, the EG-2X-NN blanket held firmly in place, preventing rill formation and sediment movement across even the steepest slopes. Vegetation established uniformly within weeks, and slopes remained stable through seasonal transitions without corrective work. The project maintained full regulatory compliance, avoided delays, and demonstrated the value of high-performance erosion control systems in complex highway reconstruction environments.
